**NASA CR-2614**

**EVALUATION OF DISPERSION STRENGTHENED  
NICKEL-BASE ALLOY HEAT SHIELDS FOR  
SPACE SHUTTLE APPLICATION**

**MCDONNELL DOUGLAS ASTRONAUTICS COMPANY**

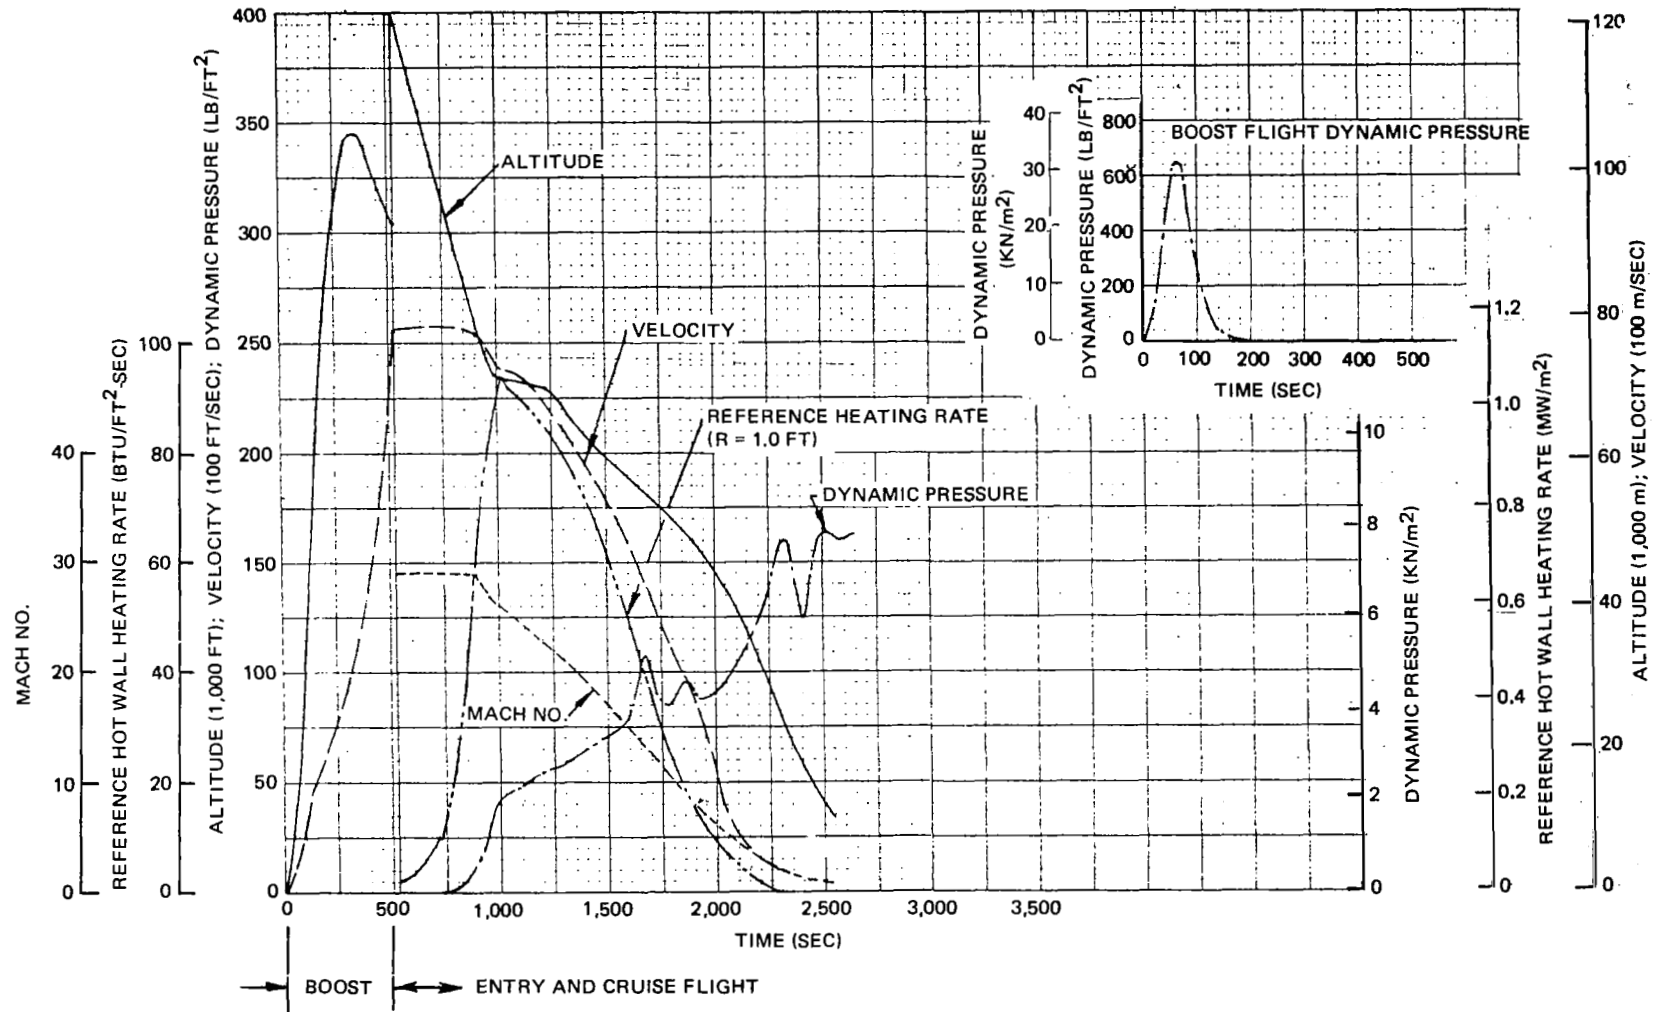
Figure 2-3. Baseline Orbiter Flight Parameters

The basic design pressures and temperatures experienced by the TPS surface panels were determined by the vehicle trajectories during boost, entry, and terminal approach phases of the mission. To define the TPS panel pressure and temperature histories, the trajectories for the baseline Orbiter were reviewed and a critical set of boost, entry and cruise trajectories were selected. From the selected trajectories critical flight parameters were defined as shown in Figure 2-3.

Using the flight parameters of Figure 2-3, the critical panel temperature and pressure environments for the selected lower surface position were established. The critical temperature and pressure conditions, shown in Figure 2-6, were then used to develop test profiles for programmed multiple-parameter cyclic tests of TD Ni-20Cr material samples and for load and temperature profiles used in the heat shield panel tests. Such test profiles are discussed subsequently in Sections 3, 5, and 6.

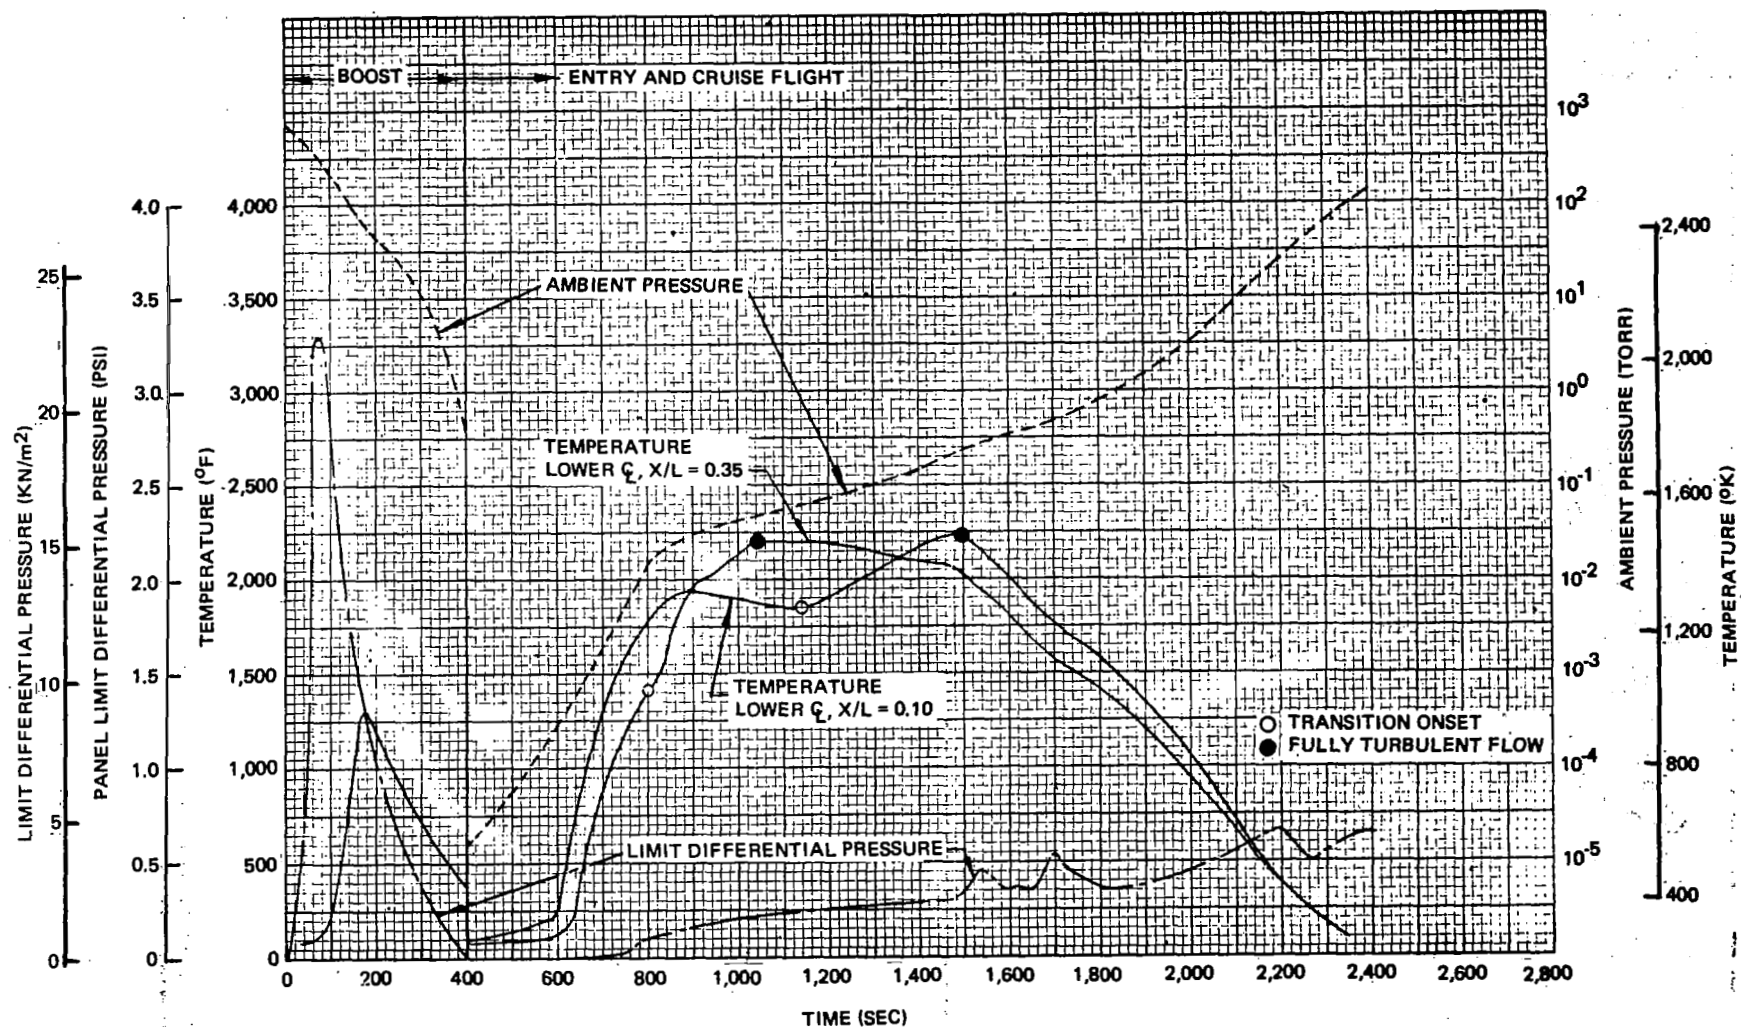
Figure 2-6. Temperature, Panel Differential Pressure, and Ambient Pressure Time-Histories

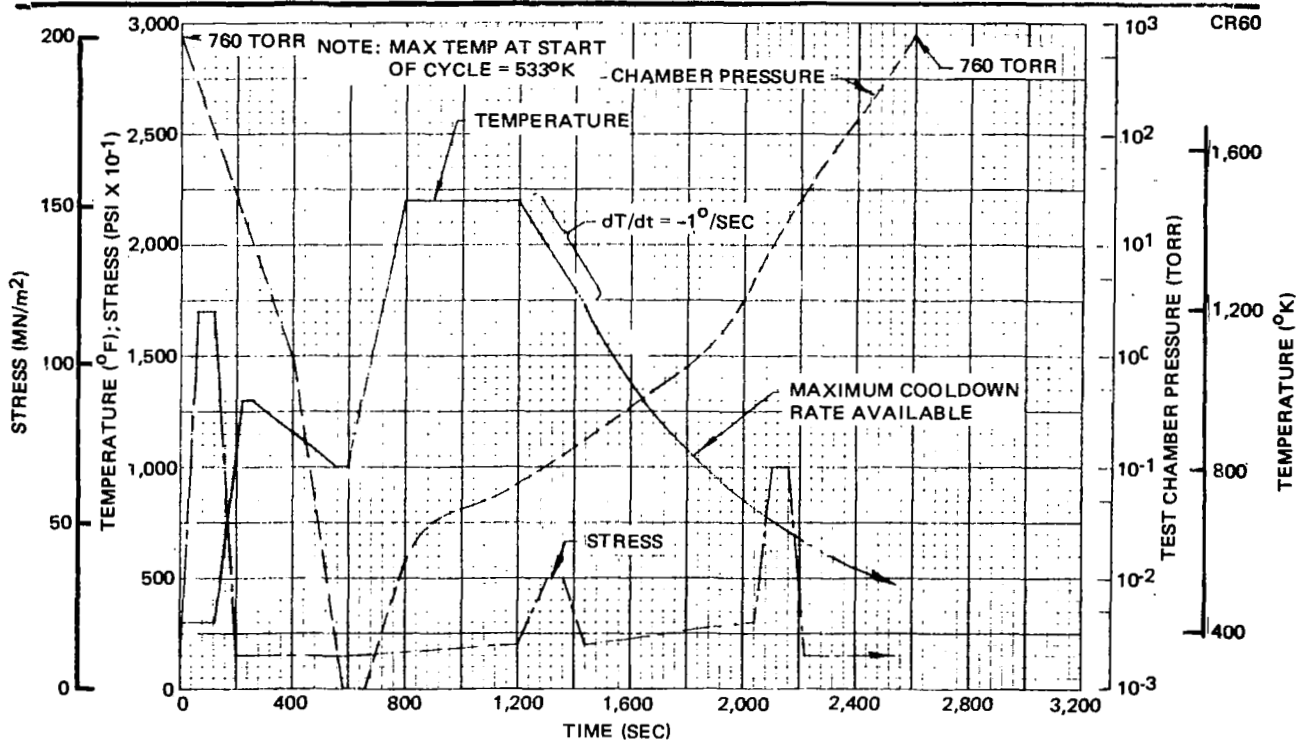
Figure 3-1. Cyclic Multiple Parameter Test Profiles

The multiple-parameter test series consisted of repeated cycles of stress, static pressure, and temperature profiles that were designed to simulate mission conditions on a Shuttle Orbiter metallic heat shield. Prior to the start of testing, all TD Ni-20Cr specimens were oxidized at 1,451°K (2,150°F) for 1 hour at 1 atmosphere air pressure to produce a dark, high-emittance surface oxide. The basic test profile of chamber pressure, temperature, and stress are shown in Figure 3-1. Temperature and chamber pressure profiles were maintained as shown in Figure 3-1 for all test samples, but the stress profiles were ratioed for different sets of test specimens. The ratios used in varying the stress profiles are given in Table 3-1, which also shows the peak stress

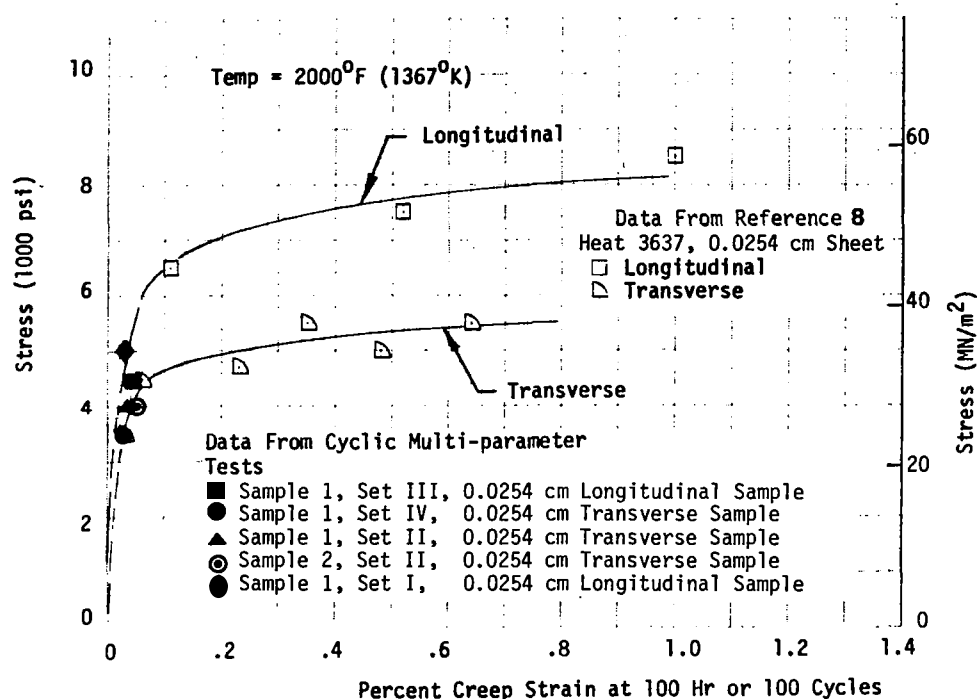
Figure 3-3. Strain Comparison Between Cyclic and Constant Load Tests

Figure 3-3 illustrates the typical elevated temperature characteristic of TD Ni-20Cr in which strains are exceptionally low ( $\epsilon \leq 0.1$  percent) in either cyclic or constant tensile load conditions until a critical stress level is applied, such a level being dependent on direction of applied stress (longitudinal or transverse) and temperature. Stresses above the critical level produced rapidly increasing cumulative strains and the samples generally

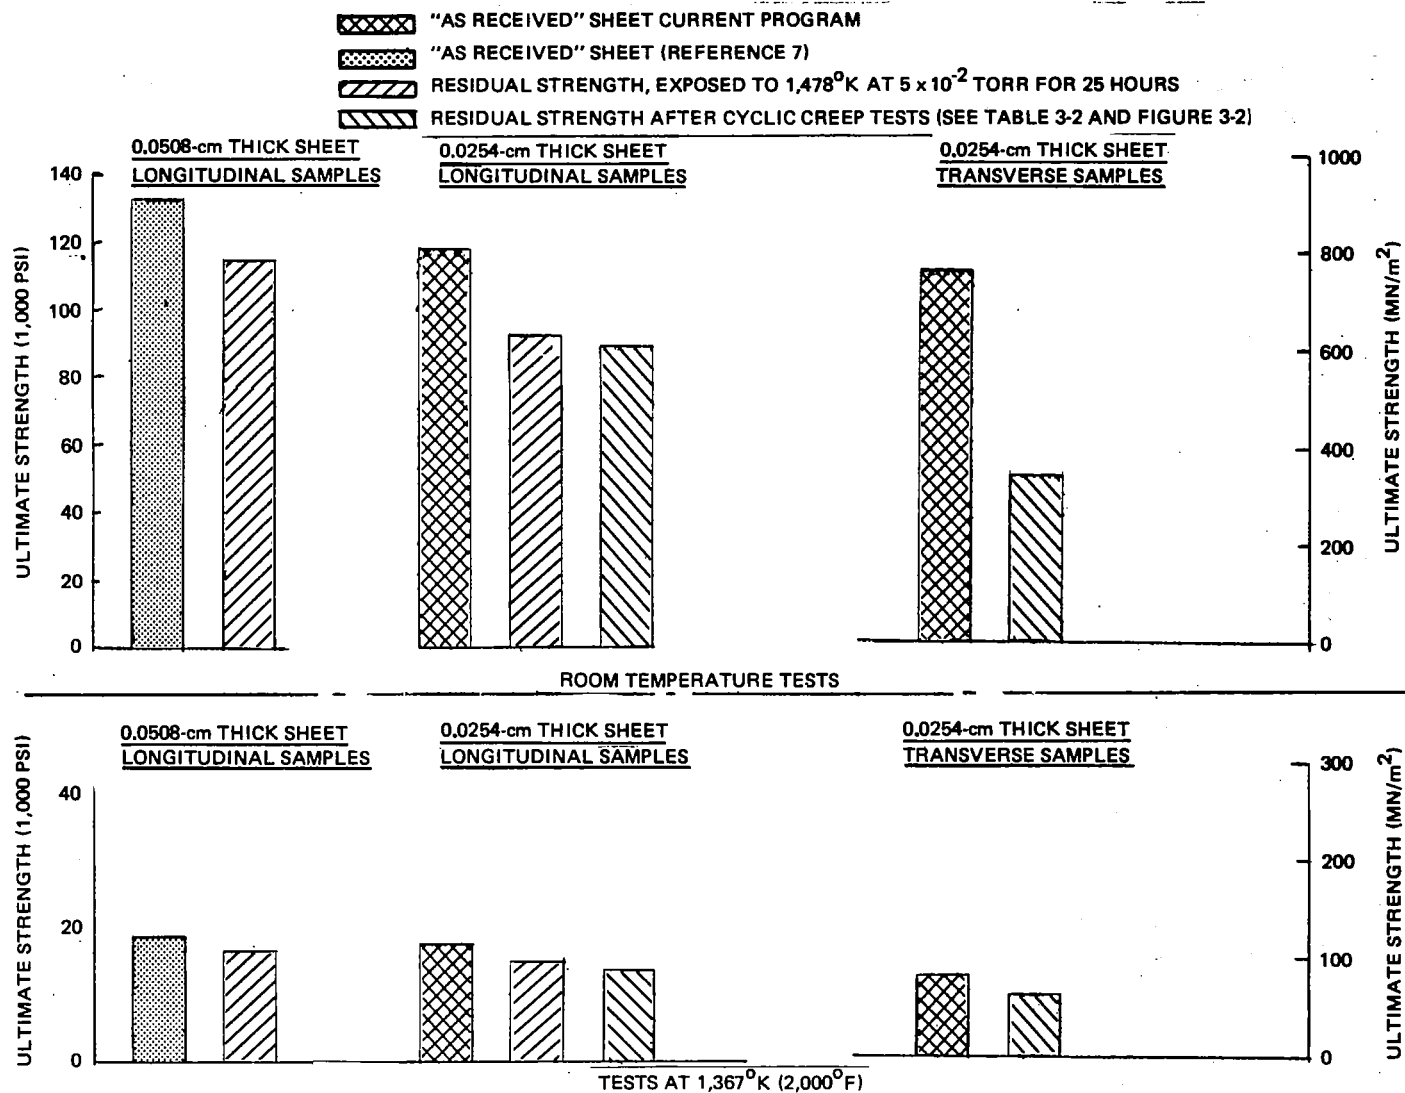
Figure 3-4. Average Ultimate Strength Comparisons of Basic TD Ni - 20 Cr Sheet and Residual Strength Samples

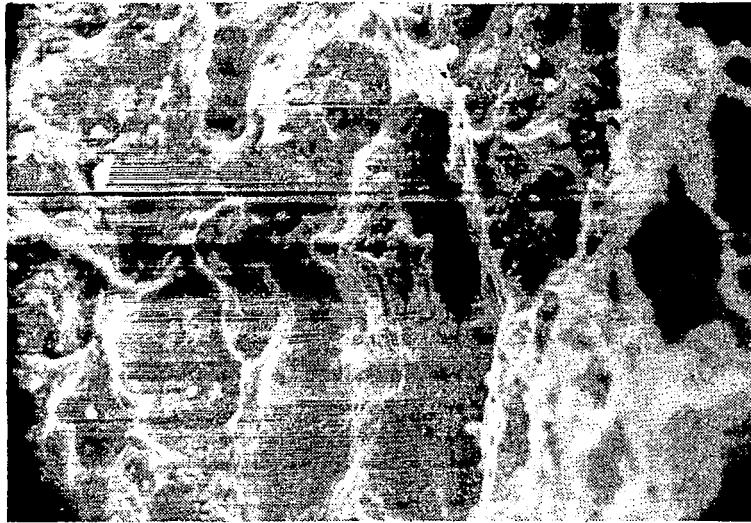
A. FRACTURE SURFACE WITHOUT OXIDATION.

B. FRACTURE SURFACE WITH APPARENT SURFACE OXIDATION.

**Figure 3-5** Photomicrographs of Fracture Edge Taken with Scanning Electron Microscope, Cyclic Creep Specimen No. 7

Photomicrographs were first taken with a scanning electron microscope (SEM) at two positions along the fracture edge of specimen No. 7, a cyclic creep sample with a transverse orientation. The two areas photographed are shown in Figure 3-5, where the difference in appearance is evident. Cyclic creep specimen No. 7 was tested for residual strength at room temperature (Table 3-2) and showed severe loss in ultimate tensile strength. Since the residual strength test of specimen No. 7 was conducted at room temperature, any oxidation of the fracture edge could have occurred only during elevated-temperature portions of the creep strain test cycles. The latter fact, combined with the low ultimate stress of  $237.5 \text{ MN/m}^2$  (34,400 psi) recorded in residual strength tests, indicates that initial intergranular cracks may have occurred during the cyclic creep strain tests.

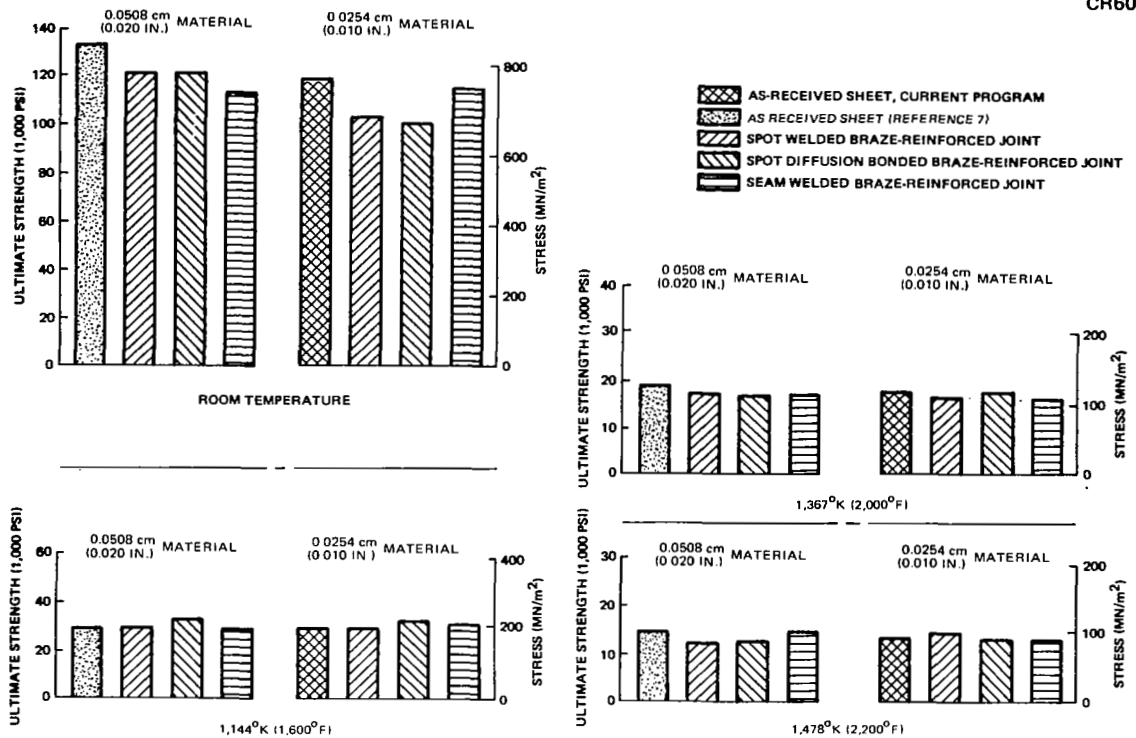
Figure 3-8. Comparison of Average Ultimate Tensile Strengths

The average ultimate strengths of the three types of braze-reinforced joints are compared in Figure 3-8 with the average strength of as-received TD Ni-20Cr sheet material at room temperature, 1,146°K, 1,368°K, and 1,477°K (1,600°F, 2,000°F, and 2,200°F). The joint stresses shown in Figure 3-8 were based on the cross-sectional area of the sheet strip outside of the joint and are therefore typical of the tensile stresses outside of the joint area. Strength differences in test data from both 0.0254-cm (0.010-in.) and 0.0508-cm (0.020-in.) joint samples are within the expected scatter for TD Ni-20Cr ultimate strength values, and the comparisons of Figure 3-8 indicate that joint efficiencies approaching 100 percent can be obtained at elevated

Inspection of the tested specimens showed failure to occur in the parent metal of all of the tested joints. At room temperature, the data of Figure 3-8 indicate a decrease in joint efficiency of approximately 10 to 15 percent. The cause of the decrease was judged to be either the result of local stress increases near the joint caused by the eccentricity in the test samples (Table 3-3) or the result of degradation of the parent material caused by the braze cycle.

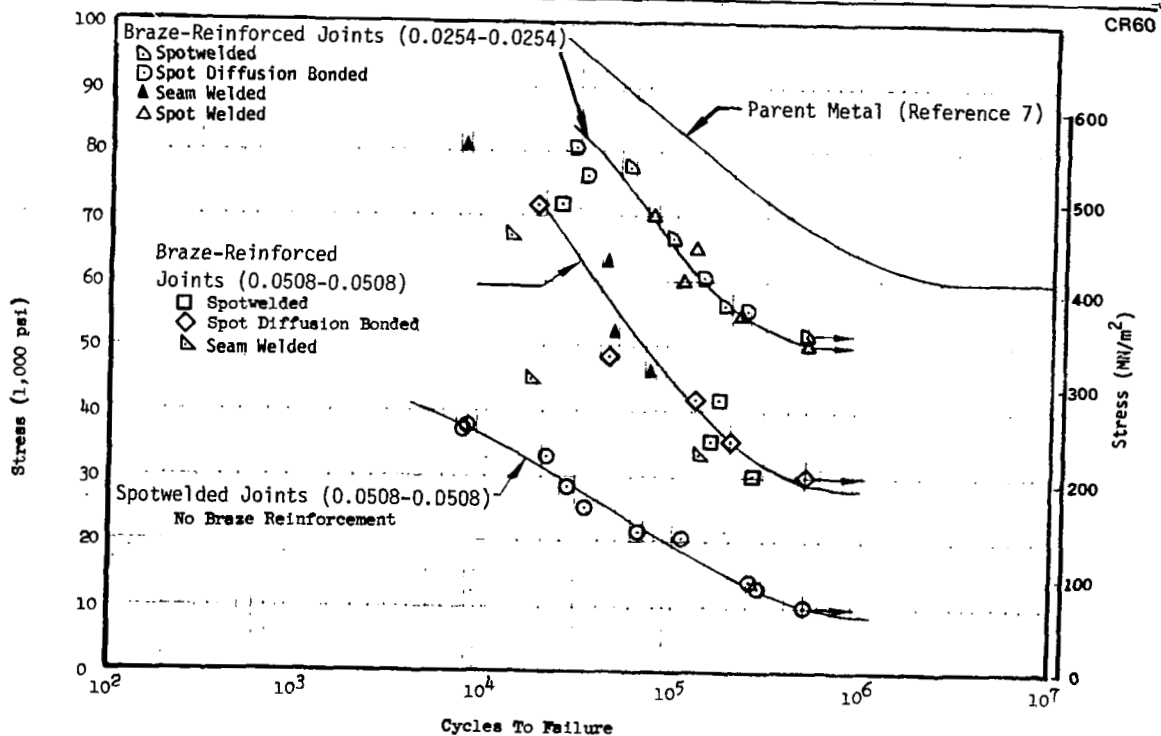
Figure 3-9. Room Temperature Fatigue Test Results for Braze-Reinforced Joints

This behavior was in contrast to the distinctly higher fatigue stress levels achieved by the 0.0254-cm (0.010-in.) thick samples in fatigue tests at room temperature (Figure 3-9). Also, the braze-reinforced joints tested at 1,368°K (2,000°F) exhibited high joint efficiencies that were comparable to parent metal values (Figure 3-10). Again, this behavior contrasted with the room temperature fatigue tests where none of the samples attained joint efficiencies near the parent metal strength levels. As in the tensile-shear tests of braze-reinforced joints, the cause of lowered fatigue strengths could be either stress increases from the eccentric single-lap configuration or degradation from the braze cycle.

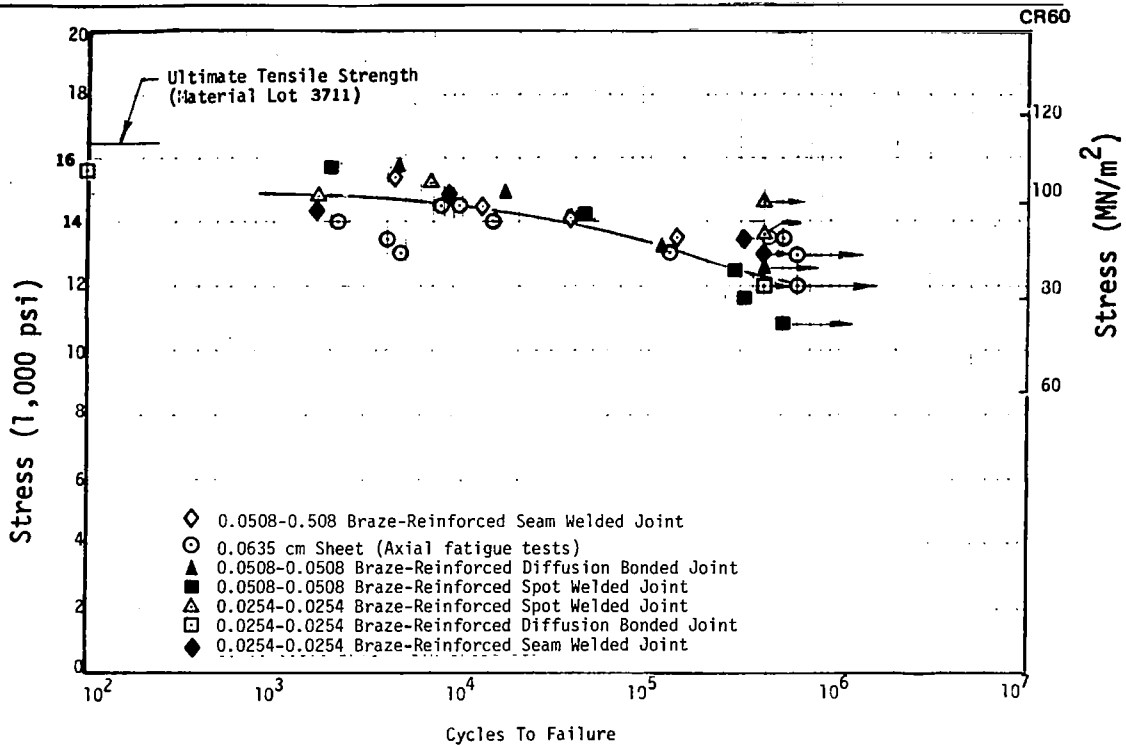
Figure 3-10. Fatigue Tests of Braze-Reinforced Joints at 1,367°K (2,000°F)

Results from fatigue tests of braze-reinforced joints conducted at 1,368°K (2,000°F) are shown in Figure 3-10. All of the braze-reinforced joints tested at that temperature showed reasonably close agreement whether made from 0.0254-cm (0.010-in.)-thick or 0.0508-cm (0.020-in.)-thick TD Ni-20Cr sheet.

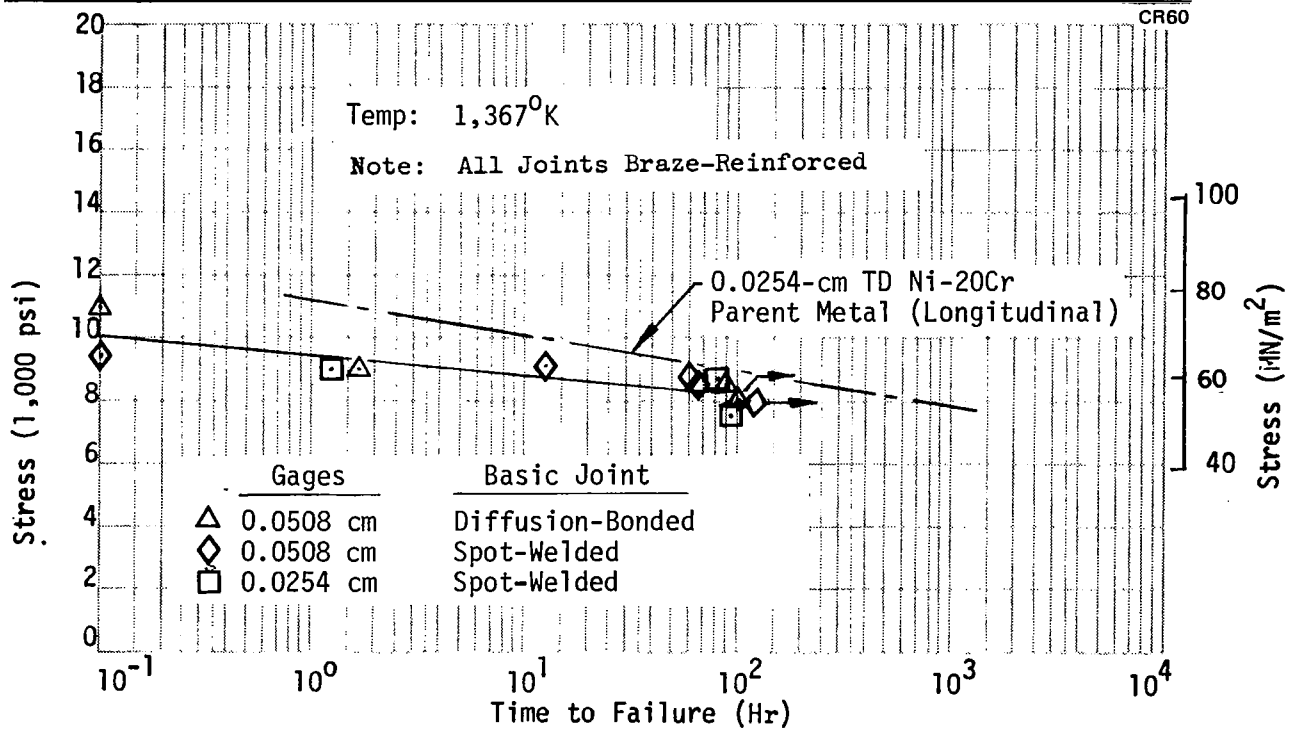
Figure 3-11. Stress Rupture Tests of Braze-Reinforced Joints at 1,367°K

Typical stress-rupture test results are presented in Figure 3-11 for braze-reinforced joints tested at 1,368°K (2,000°F). The stress-rupture strengths of the joint samples were lower than parent metal strength (see Reference 2, Appendix B) of either 0.0254-cm (0.010-in.) or 0.0508-cm (0.020-in.) sheet thicknesses. Stress-rupture strength levels from tests of parent metal samples are shown in Figure 3-11 for comparison. All joint samples used material with a longitudinal orientation, and thus the parent metal values are also shown for longitudinal samples.

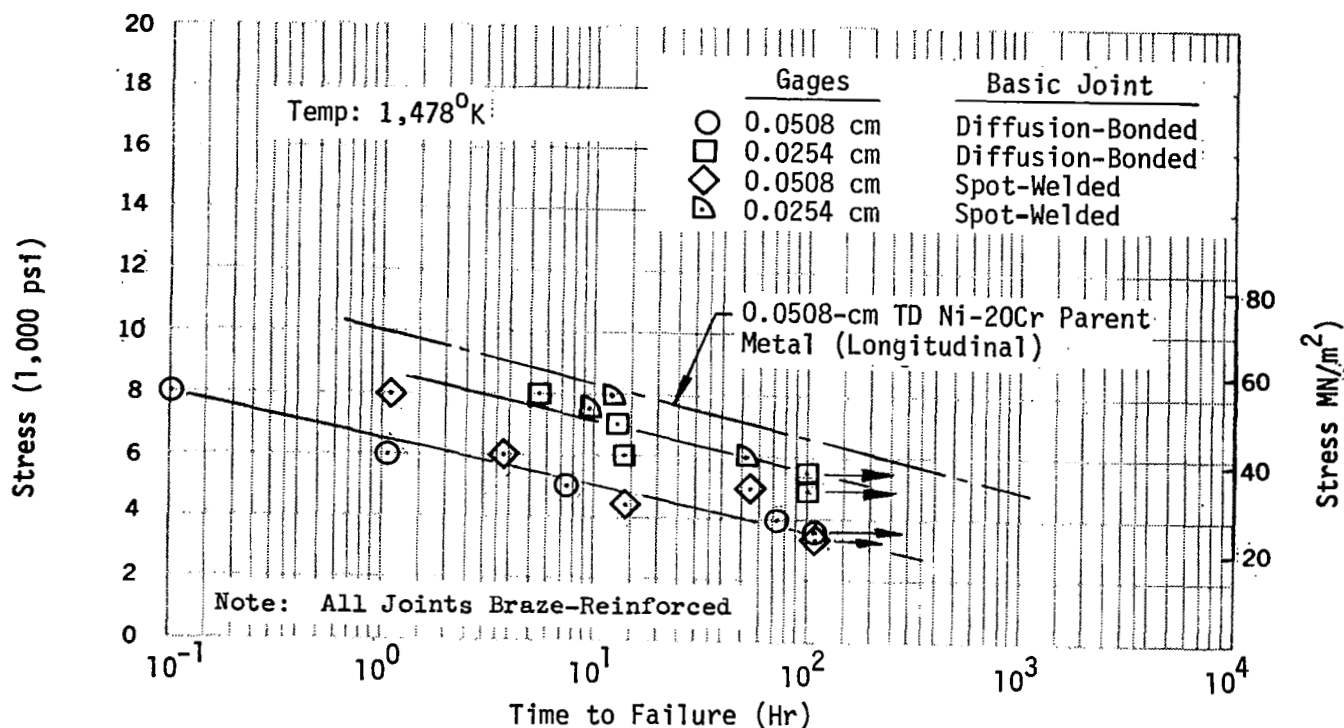
Figure 3-12. Stress Rupture Tests of Braze-Reinforced Joints at 1,478°K

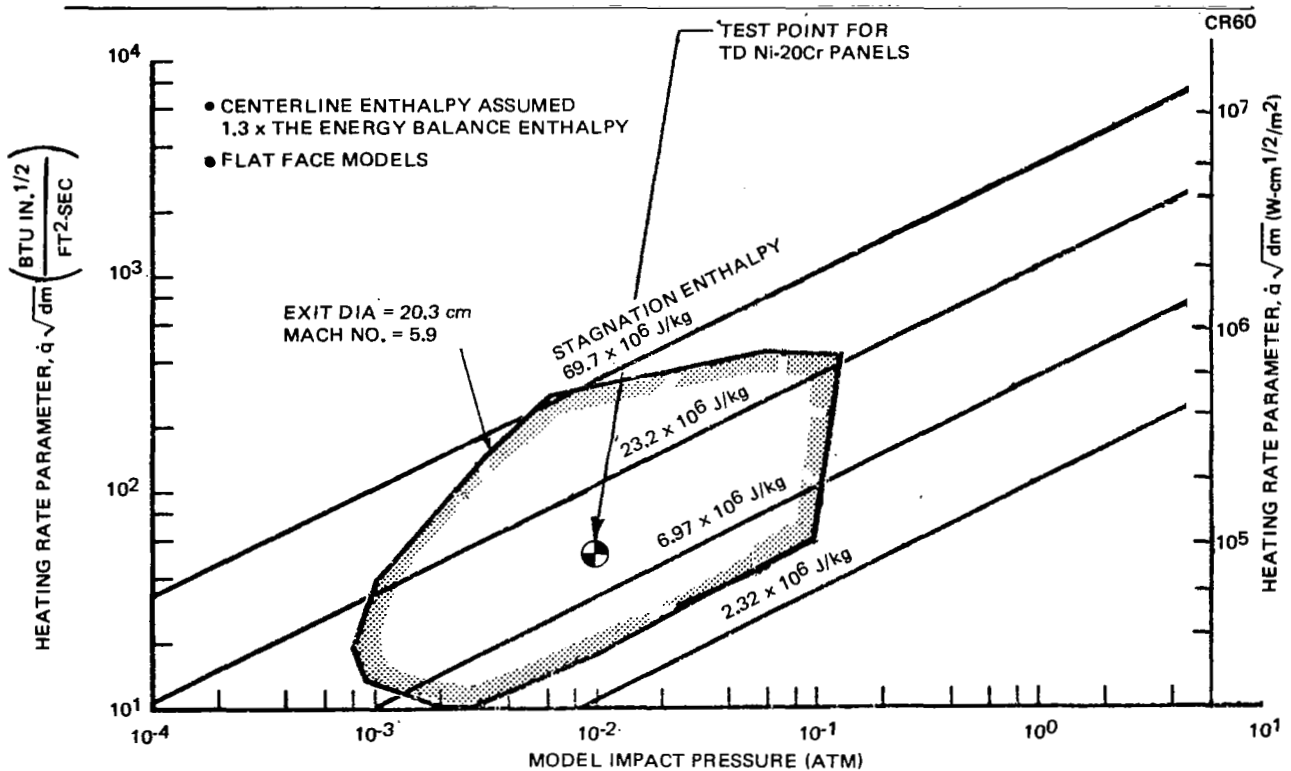
Figure 5-2. PAT Facility Testing Capability (Flat Face Model)

The operating envelope of the Plasma Arc Tunnel is shown in Figure 5-2; the point at which stream conditions were set is noted in the envelope. The noted condition was used in both the meteoroid impact panel tests and the simulated panel joint tests.

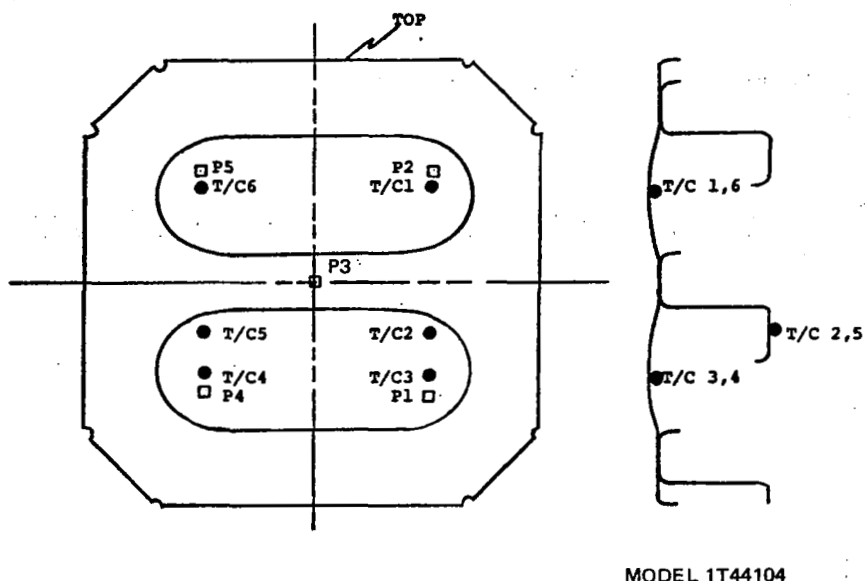
**Figure 5-3. Thermocouple and Pyrometer Sighting Locations on Meteoroid Impact Panels**

All of the test panels were instrumented with Pt/Pt-10 percent Rh thermocouples tack welded to the rear surface of the face sheet and to the stiffening members. In addition, front surface temperatures were measured with a pyrometer. Thermocouple and pyrometer sighting locations are shown in Figure 5-3.

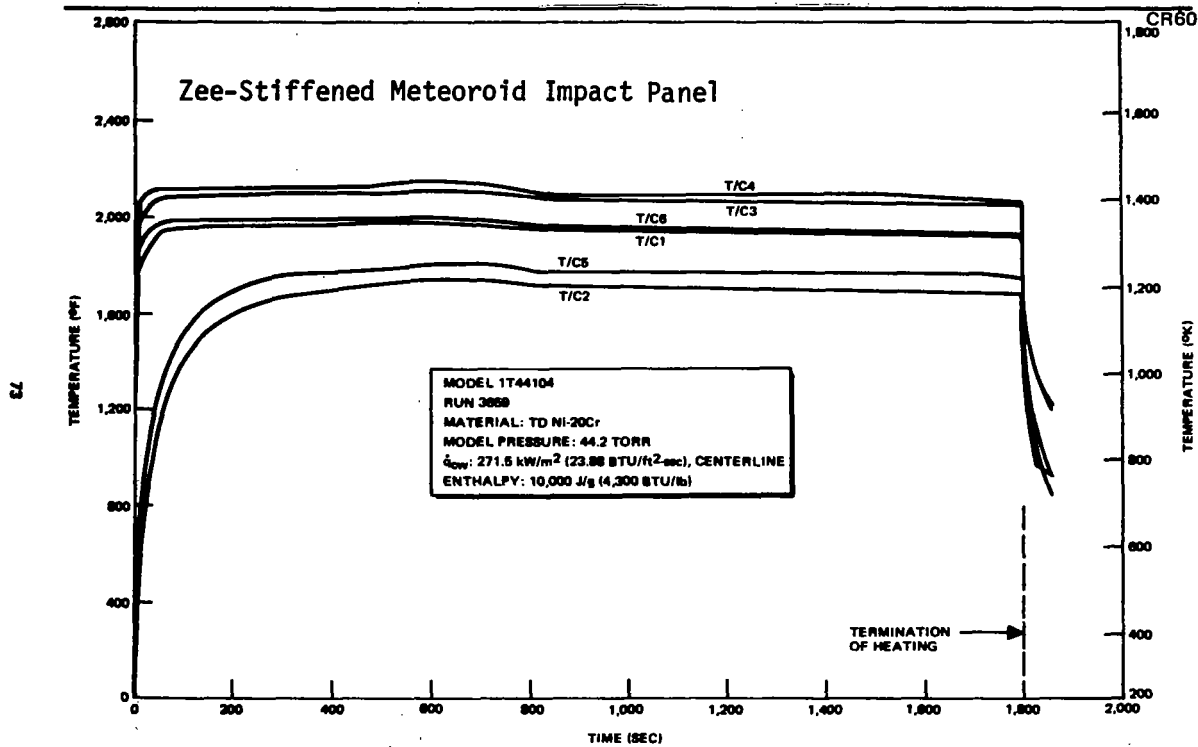
Figure 5-5. Panel Thermocouple Temperature Histories

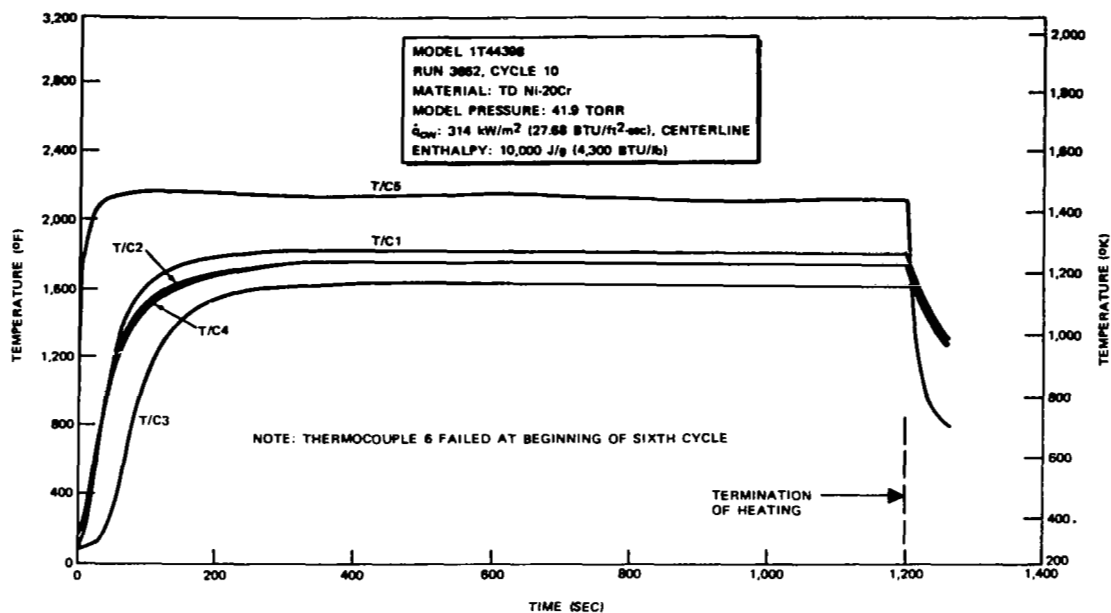
Figure 5-8. Panel Edge Joint Temperature Histories; Overlapping Edge Design

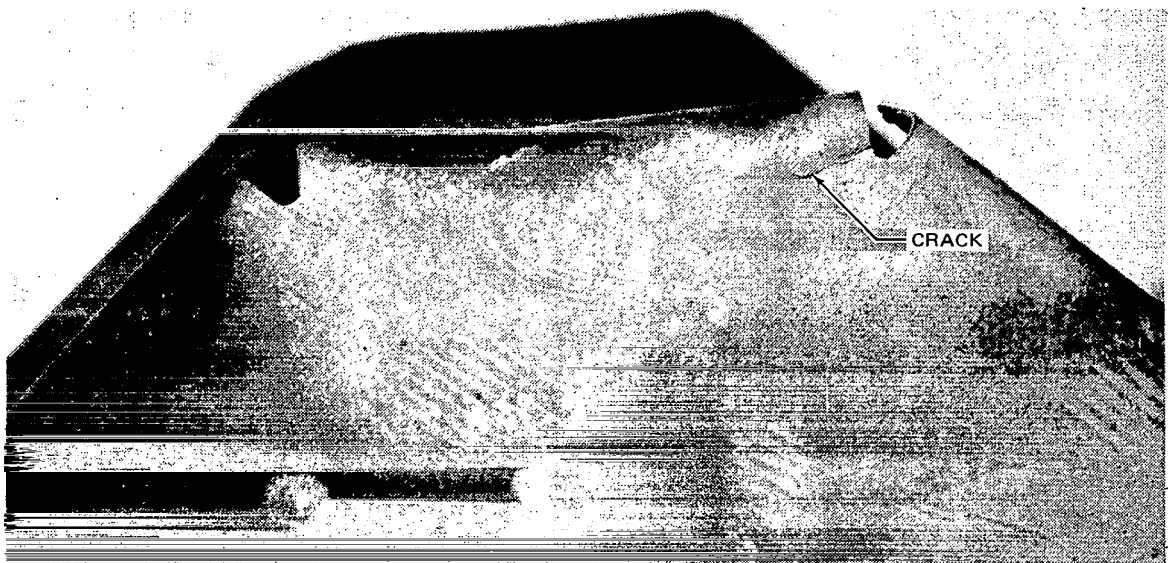
**Figure 5-11. Corner of Overlapping Panel Joint Showing Crack at Relief Radius**

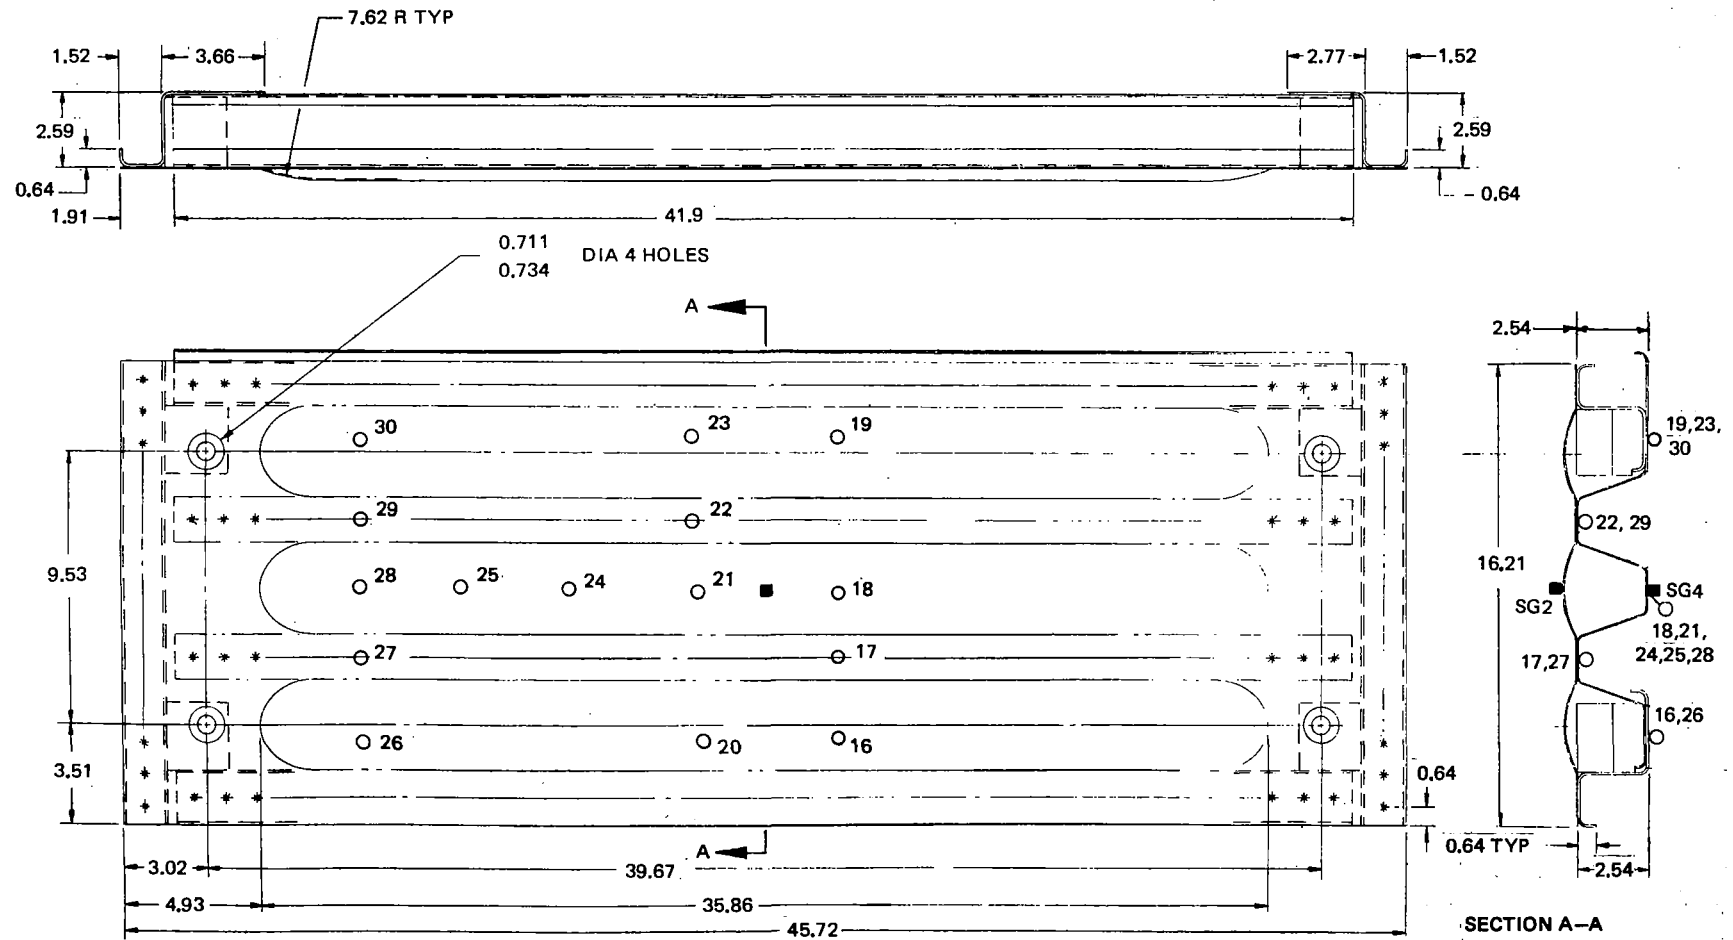
Figure 5-16. Instrumentation Points on Corrugation-Stiffened Test Panel

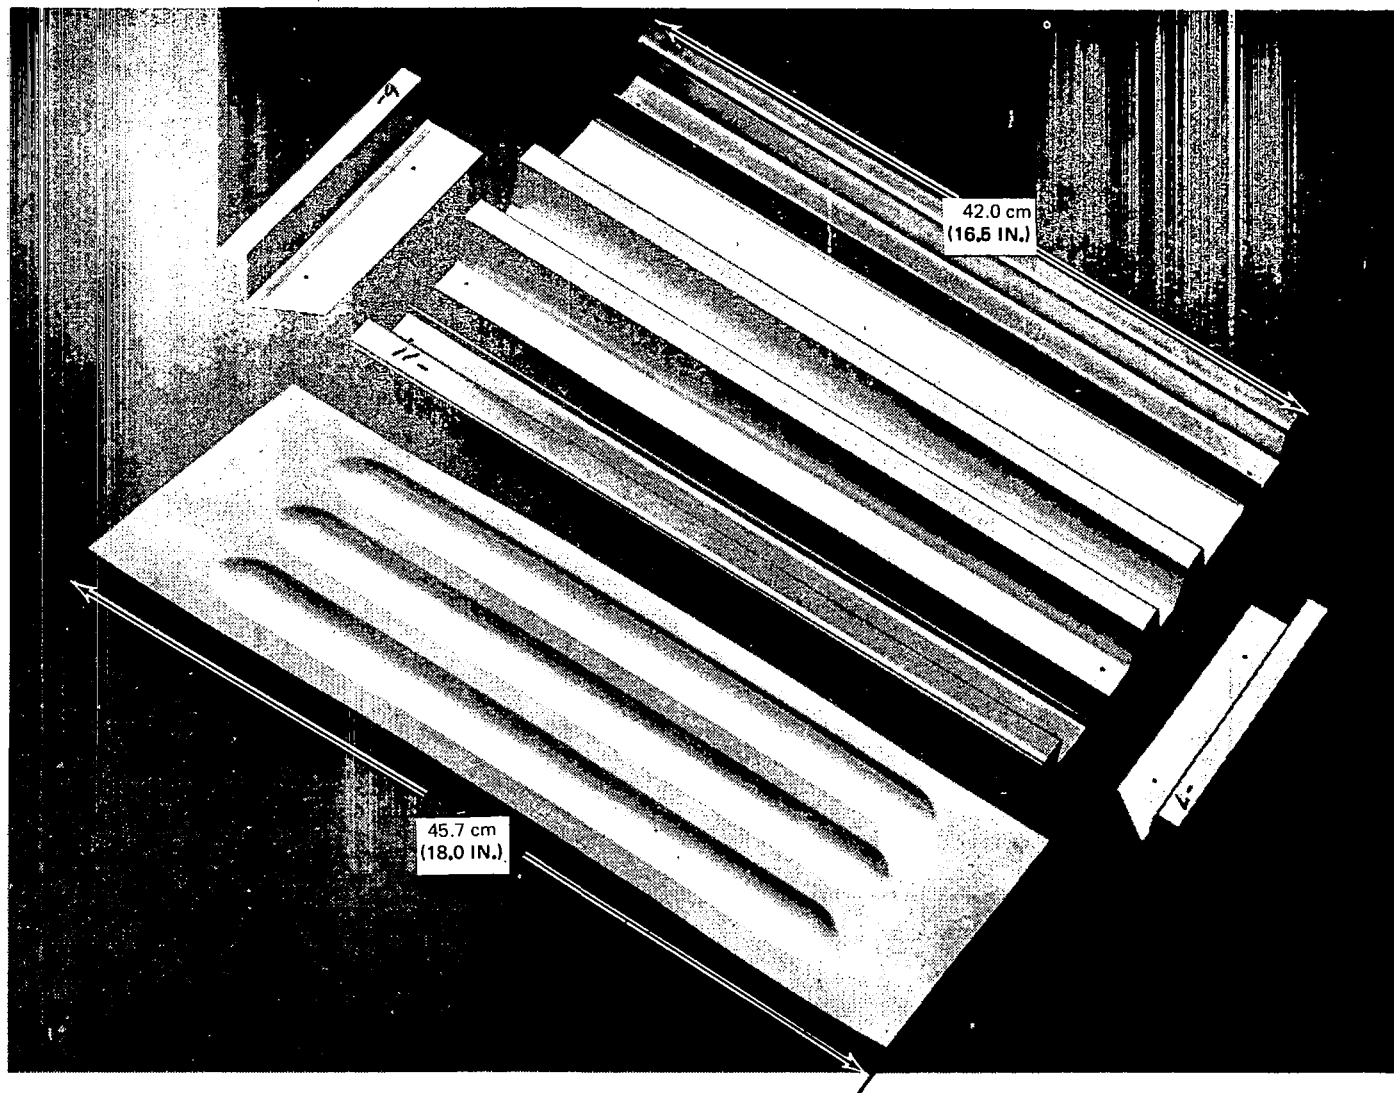
Figure 5-17 Detail Parts for Corrugation-Stiffened Test Panel

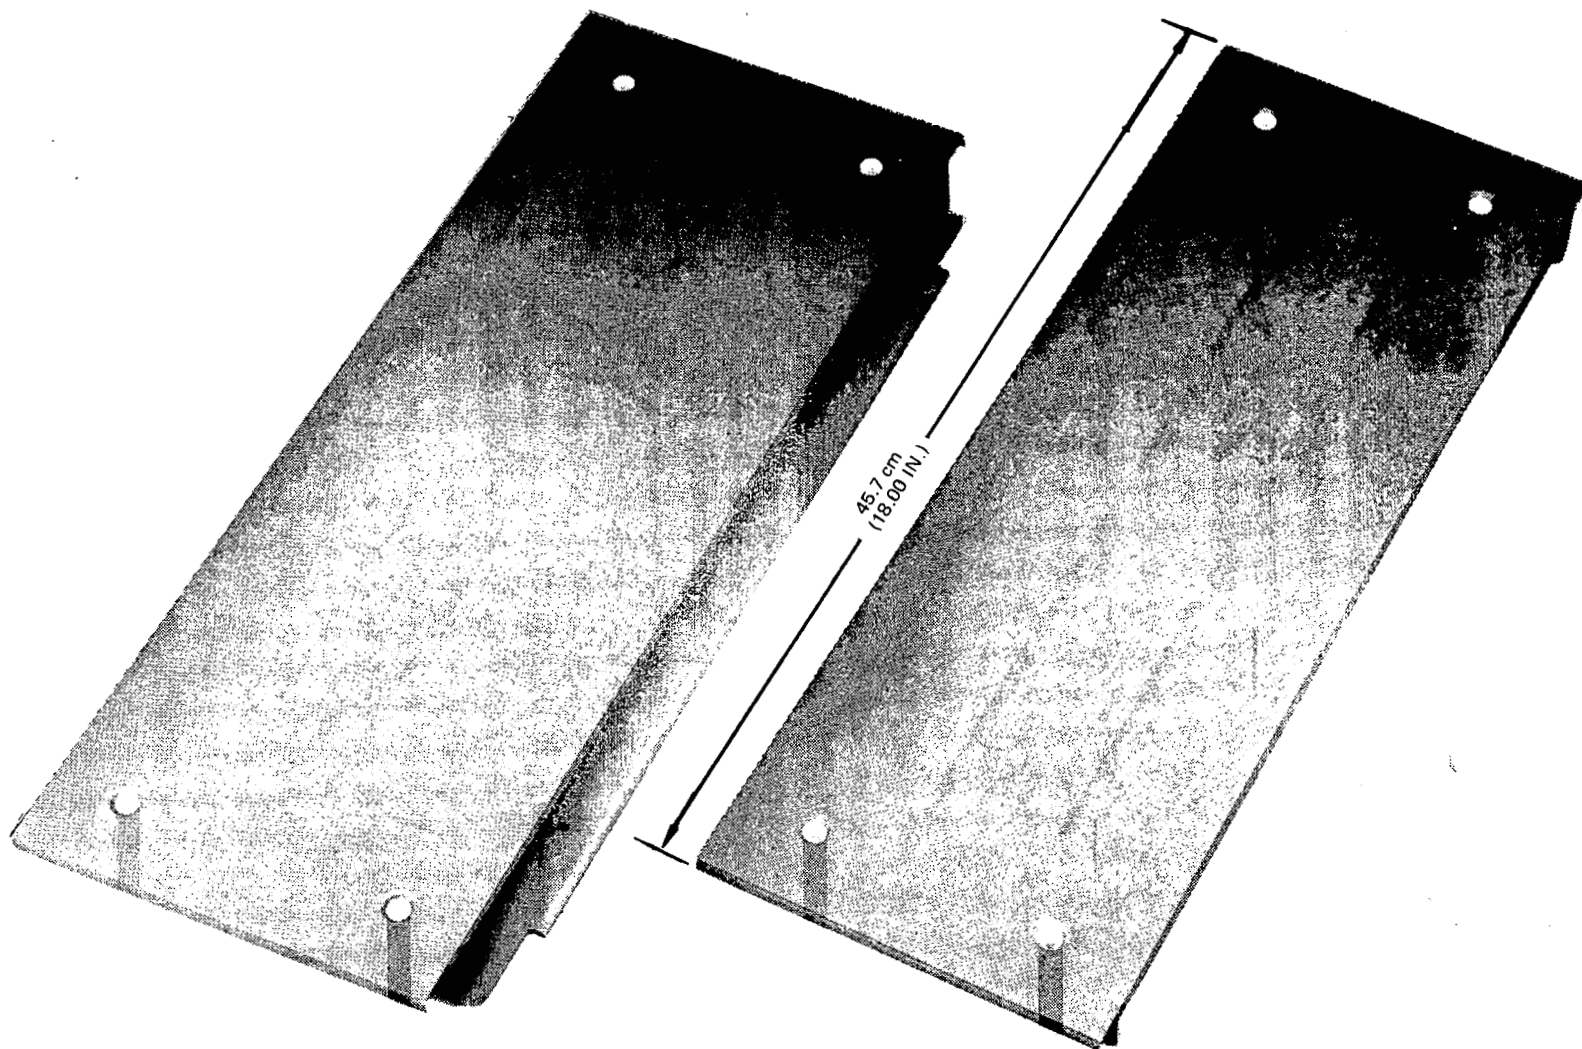
Figure 5-18. Full-Scale Subsize Test Panels
